Manhole Inspection Summary

Manhole # S45A__029MH

Insp Date: **6/13/08 9:44 AM**

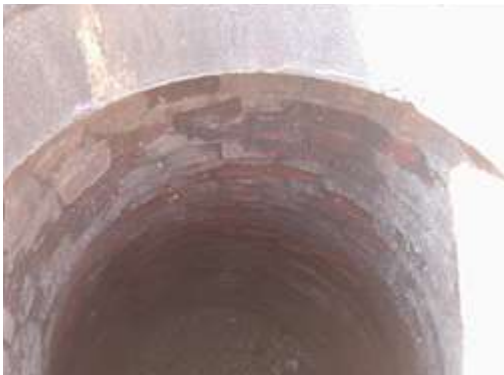
Defect 2

Infiltration: ☐ None ☒ **Joint** ☐ Cracks ☐ Mortar ☐ Roots ☒ **Wall**

Infiltration

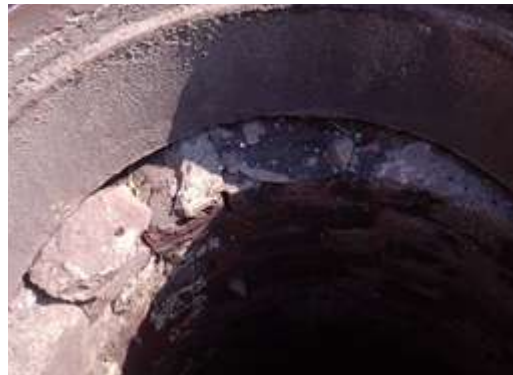
Defect 1

Adjustment Joint

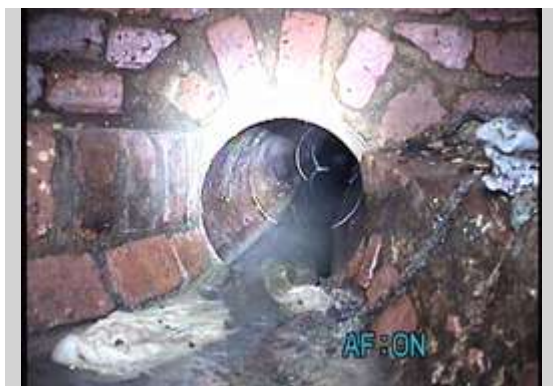
12 O'Clock Outflow

8 in. Circular Gravity Sewer
Pipe Out @ 12 O'Clock

Pipe Height: **8.4** (in.) Rod and Bar (Angled)
Pipe Material: **Clay** ☐ Pipe Lined
Invert Depth: **10.00** (ft.) Flow Characteristics: **Fast**
Deposits: ☒ None ☐ Mud ☐ Sludge ☐ Debris ☐ Grease
Silt Depth: (in.) Deposits Extent:
Infiltration: **None** Pipe Seal Cond: **Sound**

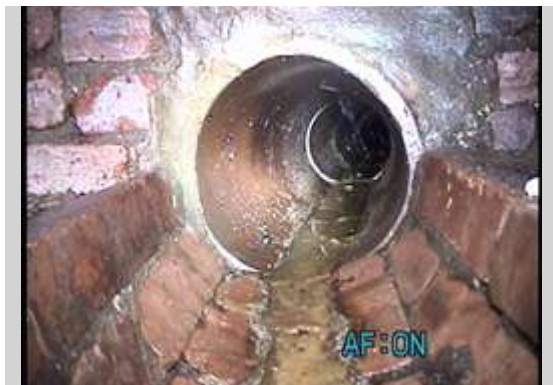
6 O'Clock Inflow

8 in. Circular Gravity Sewer
Pipe In @ 6 O'Clock

Pipe Height: **8.4** (in.) Rod and Bar (Angled)
Pipe Material: **Clay** ☐ Pipe Lined
Invert Depth: **9.55** (ft.) Flow Characteristics: **Slow**
Deposits: ☒ None ☐ Mud ☐ Sludge ☐ Debris ☐ Grease
Silt Depth: (in.) Deposits Extent:
Infiltration: **None** Pipe Seal Cond: **Sound**

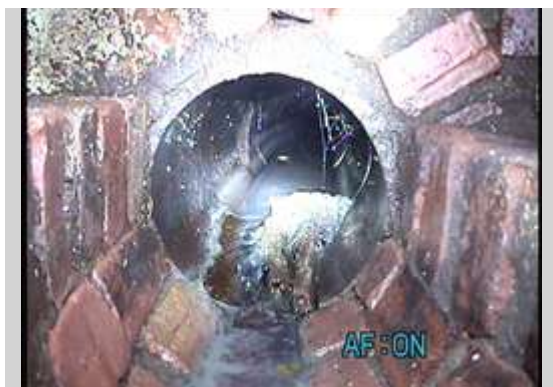
9 O'Clock Inflow

8 in. Circular Gravity Sewer
Pipe In @ 9 O'Clock

Pipe Height: **8.4** (in.) Rod and Bar (Angled)

Infiltration: **None** Pipe Seal Cond: **Sound**
